YOUR Inspection Report

1368 Labrie Avenue
Ottawa, ON K1B 3M1

RE: Report No. 1202
1368 Labrie Avenue
Ottawa, ON
K1B 3M1

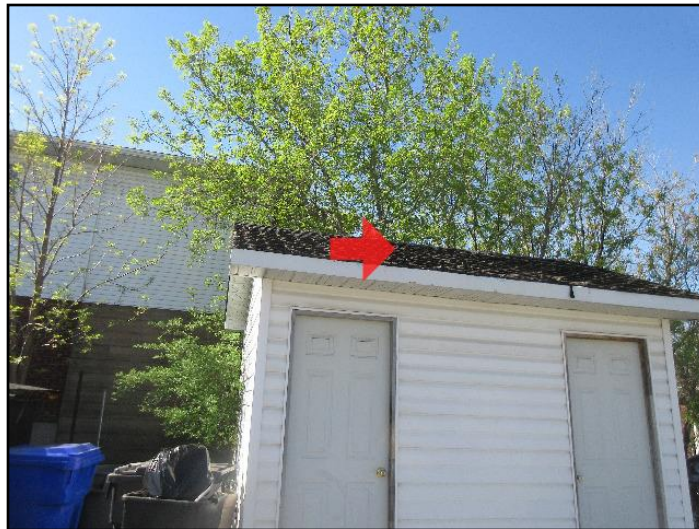
- Near end of life expectancy
On out building.

1. Near end of life expectancy

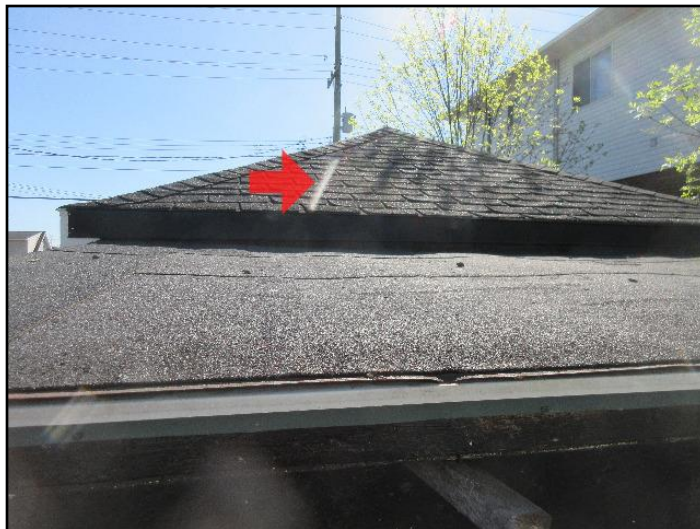
- 5-10 years
By the real estate person.
- 15-20 years
On coach house

2. 15-20 years

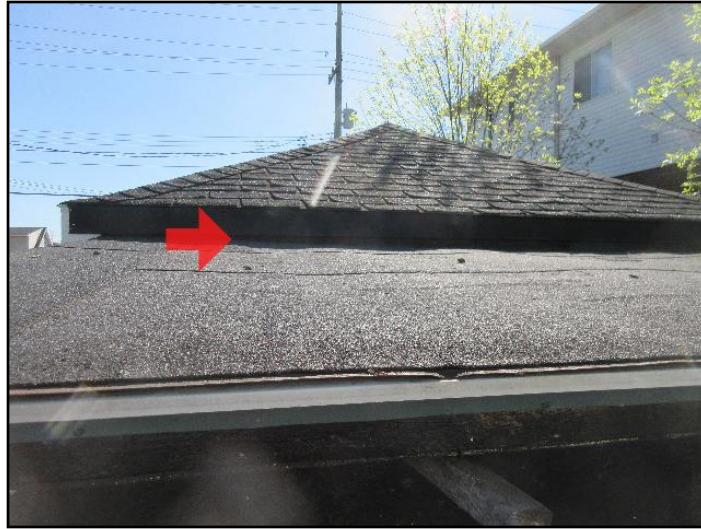
Coach House: Flashing between the roofs should be sealed to prevent water penetration.

1. **Condition:** • [Damage, loose, open seams, patched](#)

Implication(s): Chance of water damage to contents, finishes and/or structure

3. Damage, loose, open seams, patched

Task: Repair

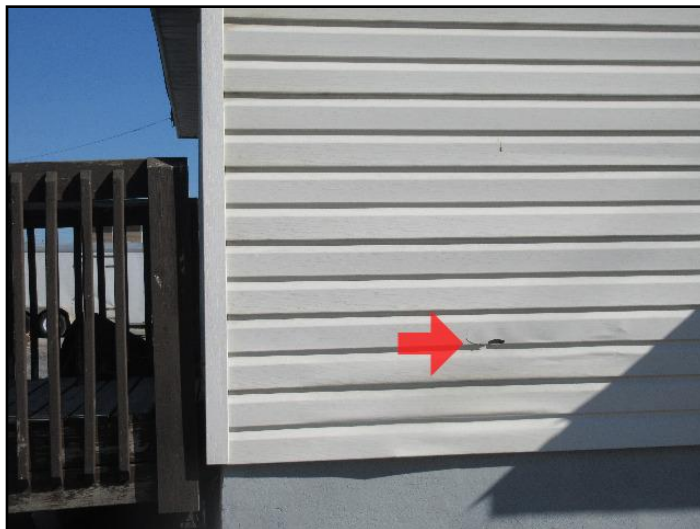
2. Condition: • [Mechanical damage](#)

Implication(s): Chance of water damage to contents, finishes and/or structure

4. Mechanical damage

Task: Repair

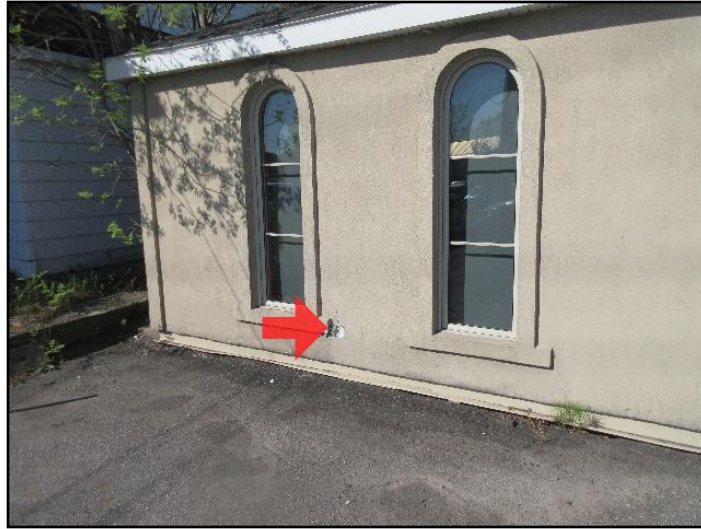
3. Condition: • [Mechanical damage](#)

Implication(s): Chance of water damage to contents, finishes and/or structure | Material deterioration

5. Mechanical damage, coach house

Task: Repair

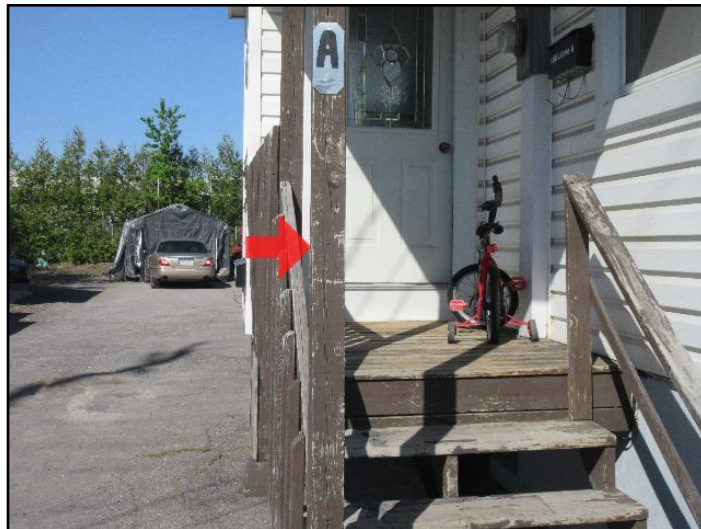
Posts that are over 5 ft 10 in. height have to be built using 6x6 posts and cemented in place.

Implication(s): Weakened structure

4. **Condition:** • Poorly built

6. Poorly built

Task: Repair or replace

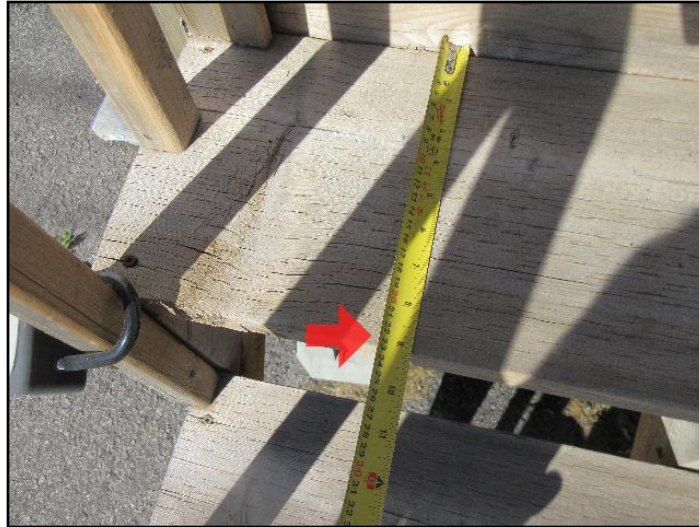
Stairs have an outward slope.

5. **Condition:** • [Stair run too small or not uniform](#)

Implication(s): Trip or fall hazard

7. Stair run too small or not uniform

Task: Repair or replace

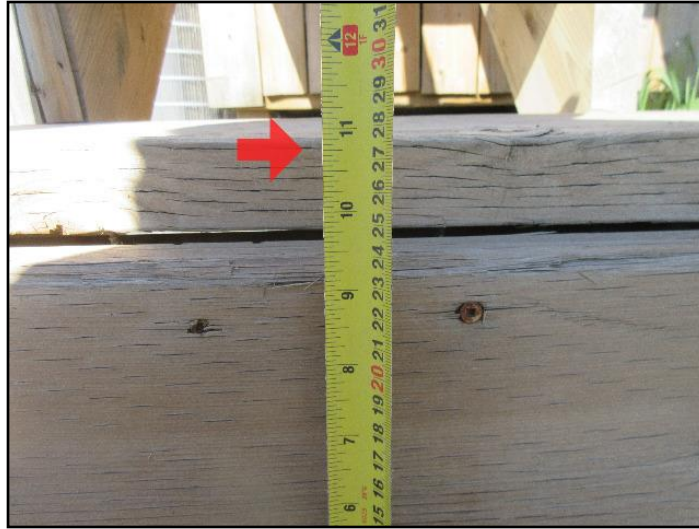
Step too high.

6. Condition: • [Stair rise too big or not uniform](#)

Implication(s): Trip or fall hazard

8. Stair rise too big or not uniform

Task: Repair or replace

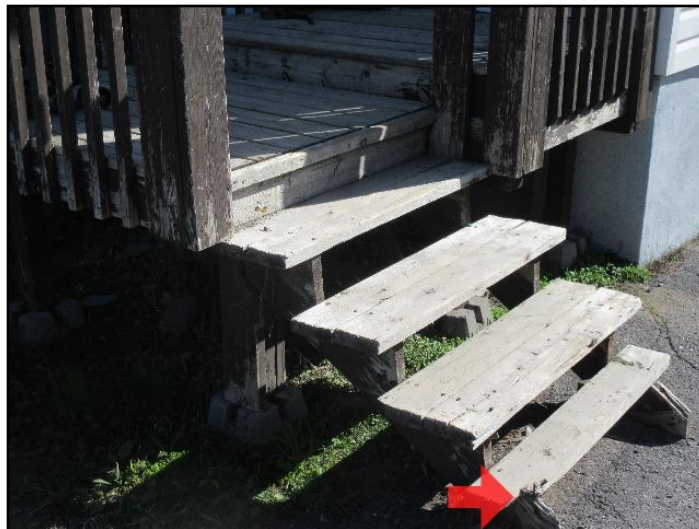
7. Condition: • [Stair rise too big or not uniform](#)

Bottom of stringer missing, railing missing.

Implication(s): Trip or fall hazard

9. Stair rise too big or not uniform

Task: Repair or replace

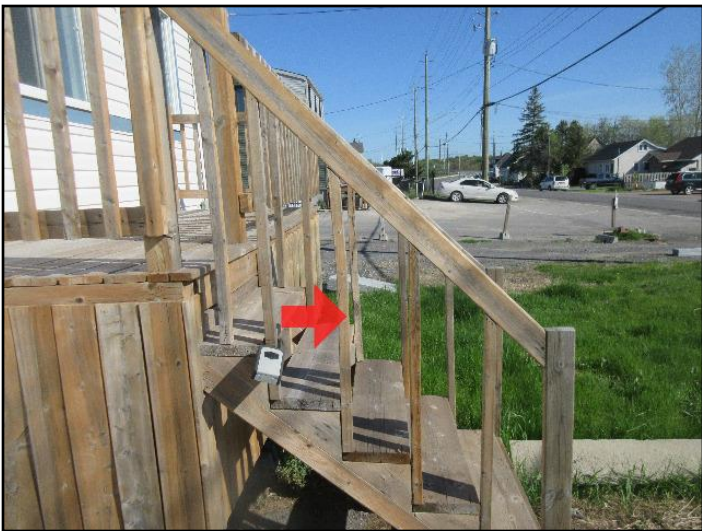
8. Condition: • [Openings between spindles \(balusters\) too large](#)

Implication(s): Fall hazard

10. Openings too wide

Task: Repair or replace

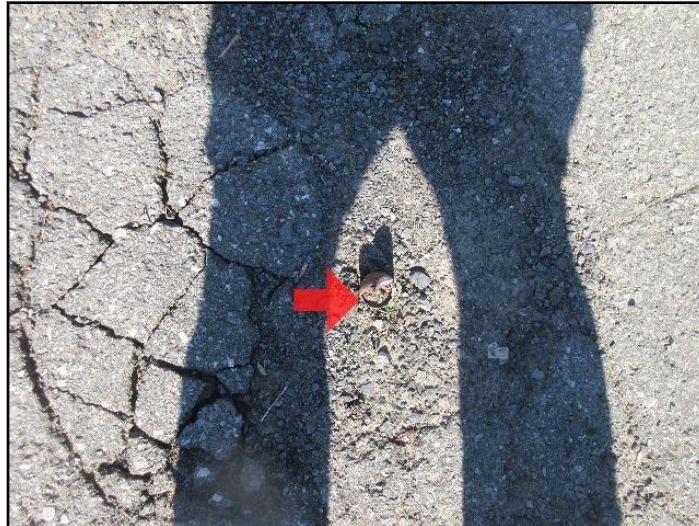
9. Condition: • [Uneven \(trip hazard\)](#)

Broken standpipe Safety issue.

11. *Uneven (trip hazard)*

Task: Repair

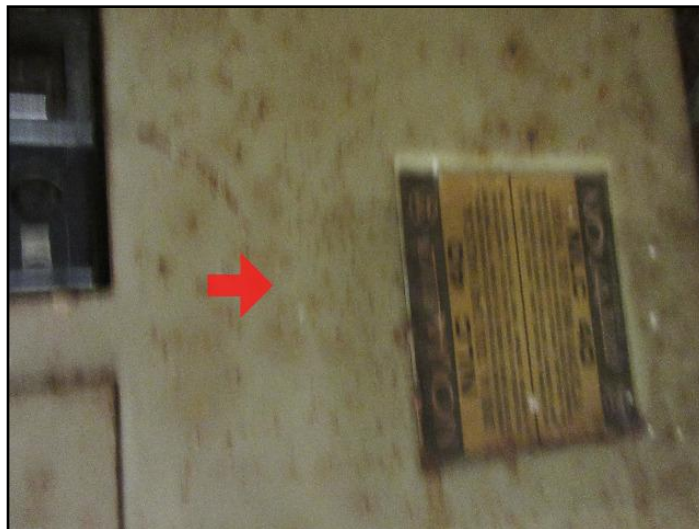
10. Condition: • [Rust or water in panel](#)

Implication(s): Electric shock | Fire hazard

12. Rust in panel

Further investigation is recommended to determine cause of rust present on the electrical panels. Recommend to inspect with ESA.

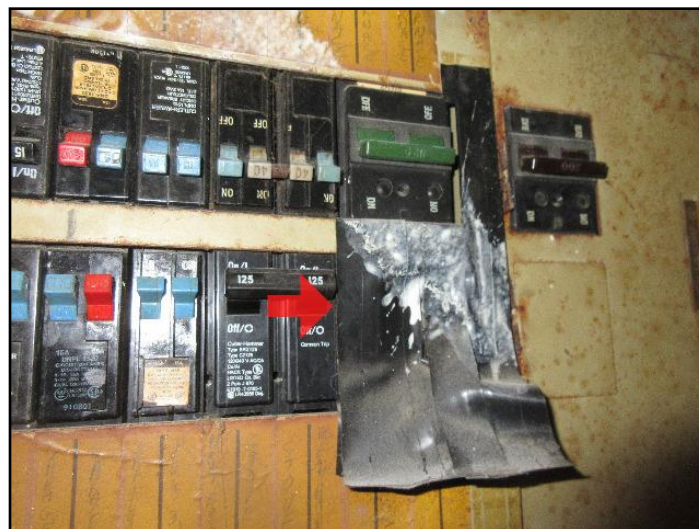
11. Condition: • [Openings in panel](#)

Implication(s): Electric shock | Fire hazard

13. Openings in panel

Black tape should be replaced with a proper anti shock cap.

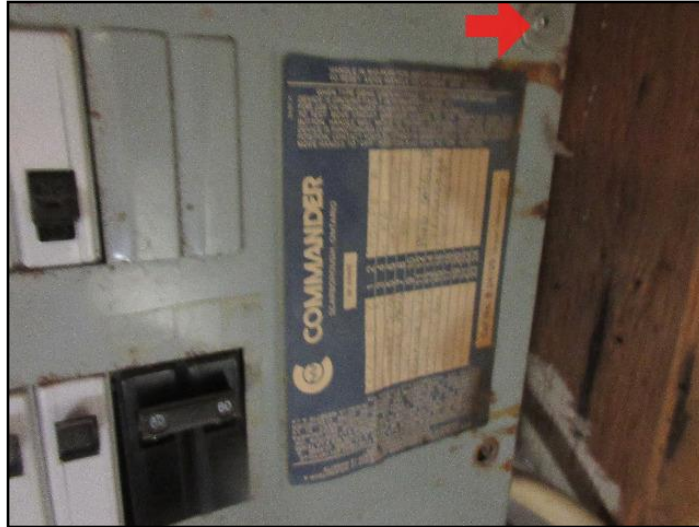
12. **Condition:** • Inappropriate panel screws.

14. Inappropriate panel screws.

Task: Replace

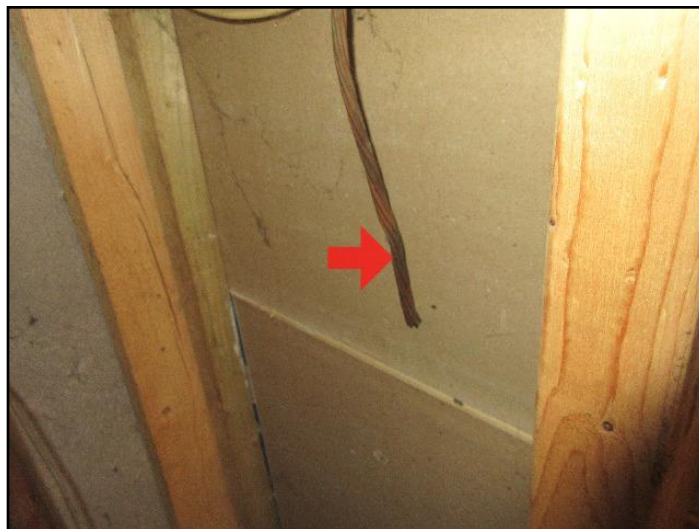
13. Condition: • [Not well secured](#)

Implication(s): Electric shock | Fire hazard

15. Not well secured

Grounding wire should be reconnected to copper pipe. Safety issue.

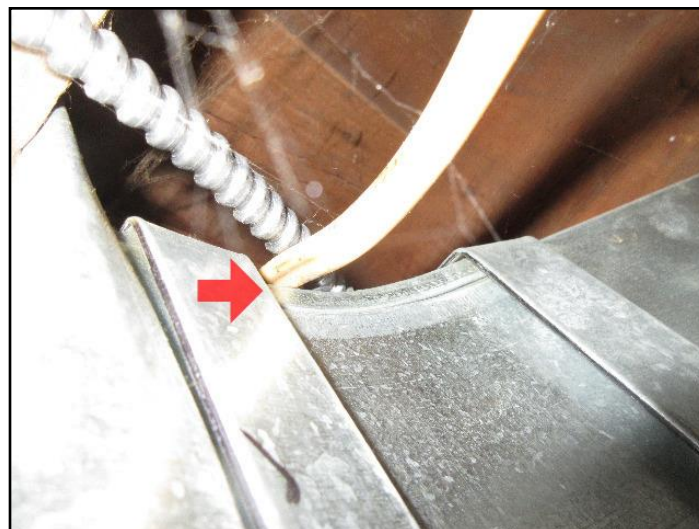
14. Condition: • [Too close to/touching duct, pipe, vent or chimney](#)

Implication(s): Electric shock | Fire hazard

16. Too close to/touching duct, pipe, vent or...

Wires should not be touching duct, insulation can be placed between the wire and duct.

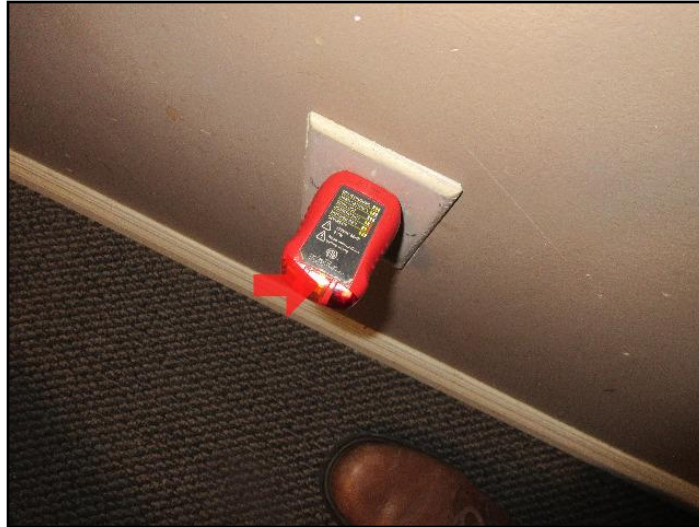
15. Condition: • [Damage](#)

Implication(s): Electric shock | Fire hazard

17. *Damage*

Task: Repair

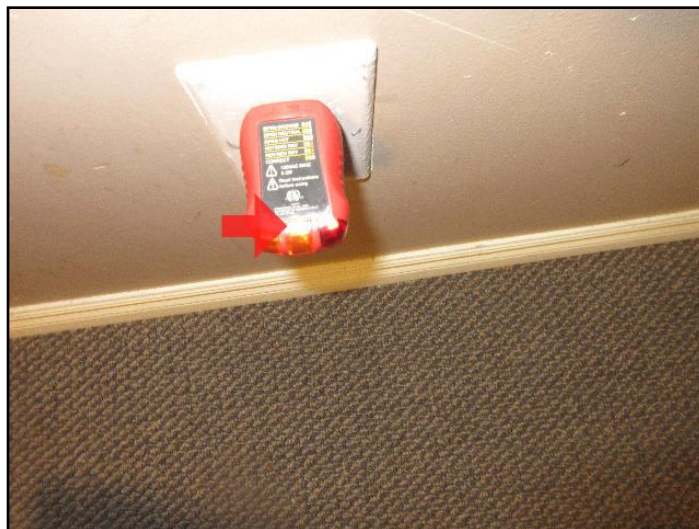
16. Condition: • [Open hot](#)

18. *Open hot*

Task: Repair

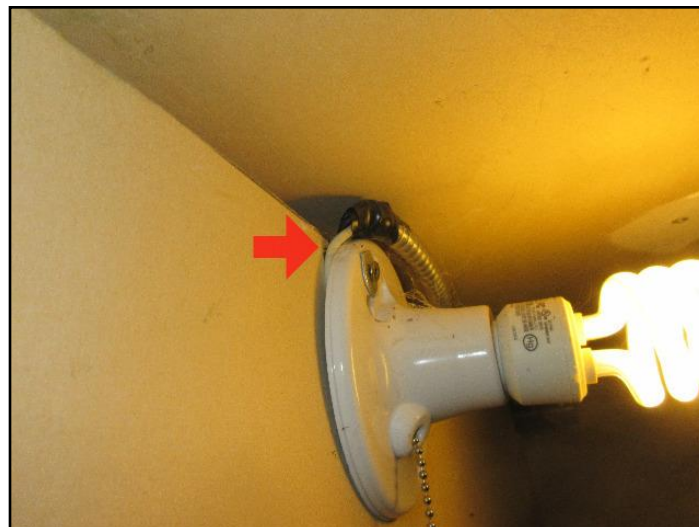
18. Condition: • Wrong install

Missing a receptacle box.

19. Wrong install (coach house)

Task: Improve

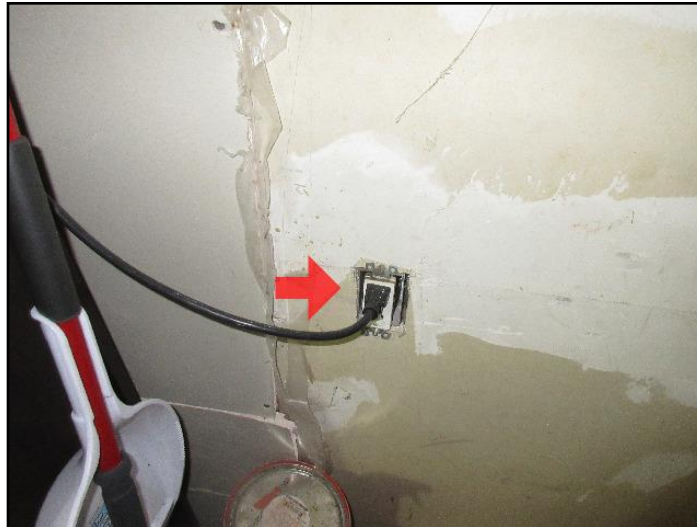
19. Condition: • [Missing](#)

20. Missing (coach house)

Receptacle needs a cover plate

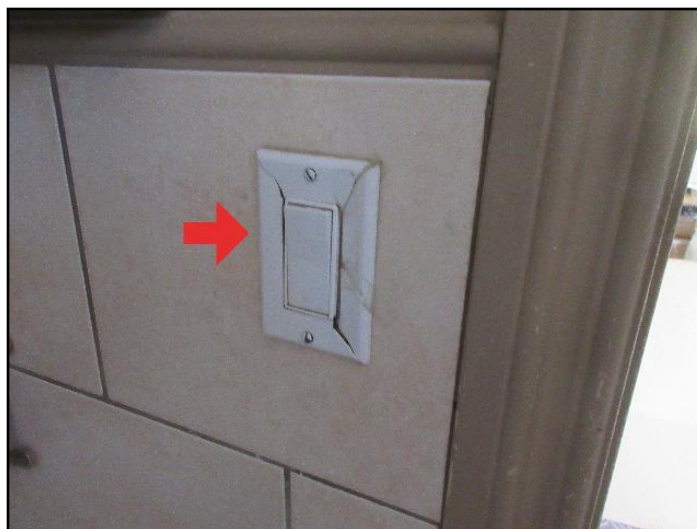
20. Condition: • For switch is damaged

21. cover plate broken

Task: Replace

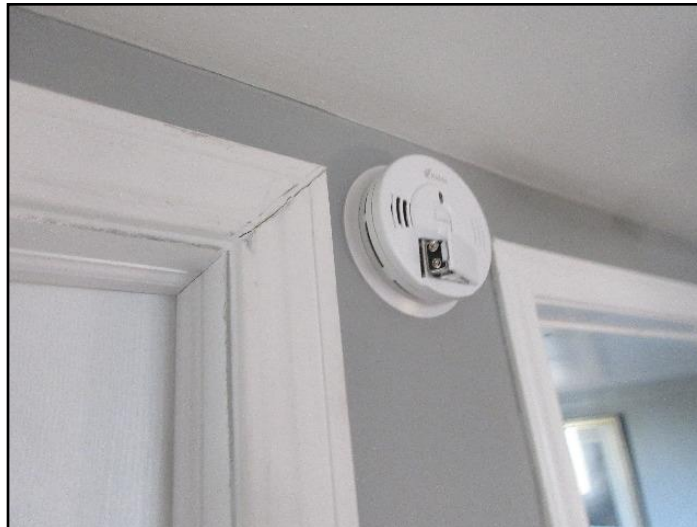
23. Condition: • [Inoperative](#)

Implication(s): Fire hazard

22. Inoperative

Task: Improve

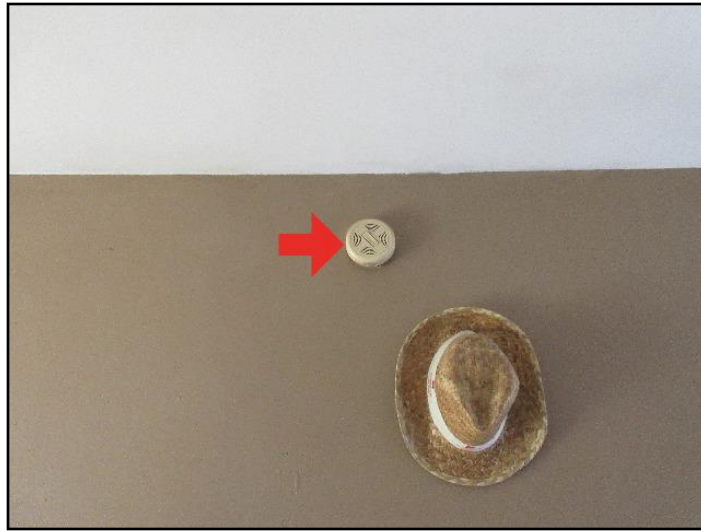
24. Condition: • Old

Implication(s): Life safety hazard

23. Old

Replace

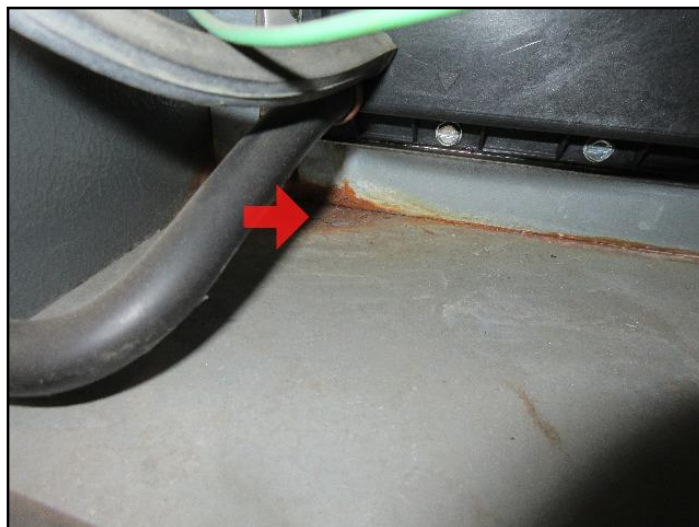
26. Condition: • [Rust](#)

Possible condensation leak inside furnace. Recommend to have an HVAC company further inspect.

Implication(s): Material deterioration | Reduced system life expectancy

24. Rust

Task: Further evaluation

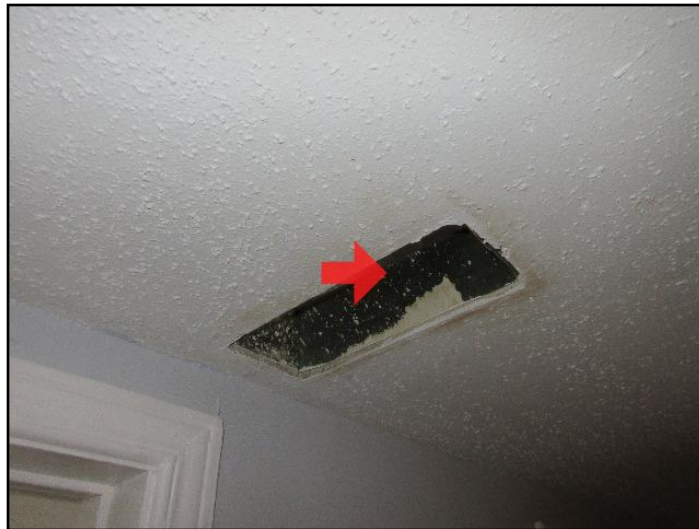
27. Condition: • Missing

25. Missing

Task: Replace

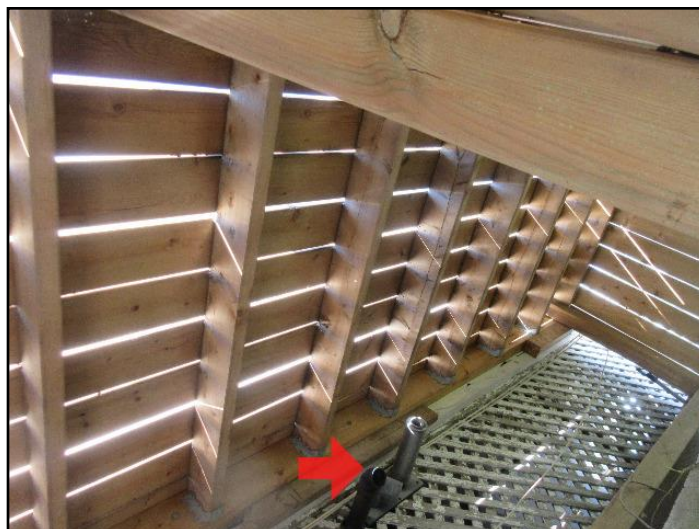
28. Condition: • [Poor connections](#)

Implication(s): Equipment not operating properly | Hazardous combustion products entering home

26. Poor connections

Vent pipe located under front deck, relocate away from deck.

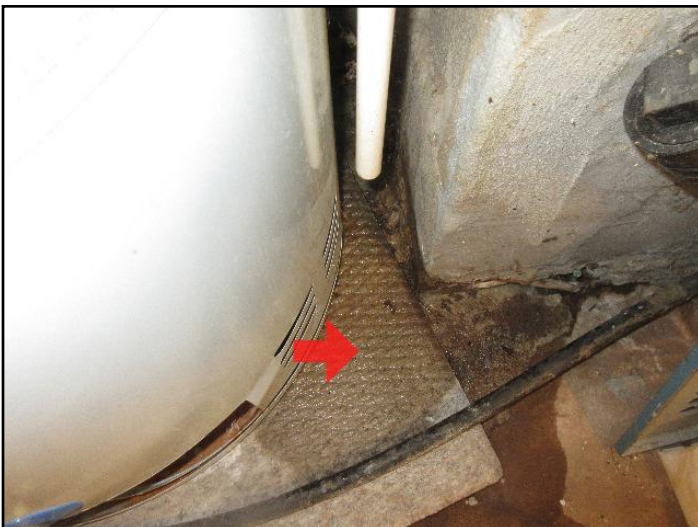
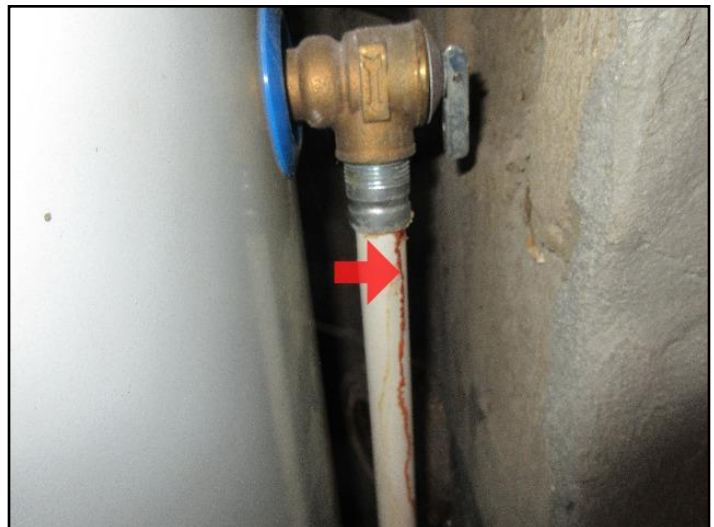
29. Condition: • [Leaking](#)

Implication(s): Chance of damage to finishes

27. Leaking

28. Leaking

Recommend to have a plumber to inspect and repair.

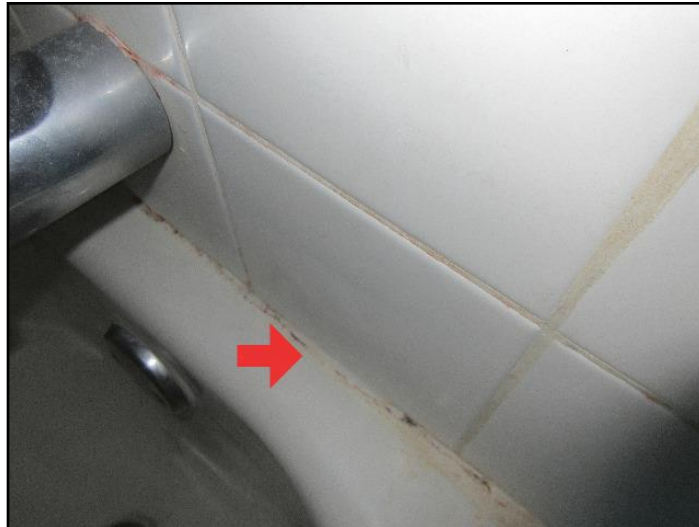
30. Condition: • [Caulking loose, missing or deteriorated](#)

Implication(s): Chance of water damage to contents, finishes and/or structure

29. *Caulking loose, missing or deteriorated*

Replace caulking around tub

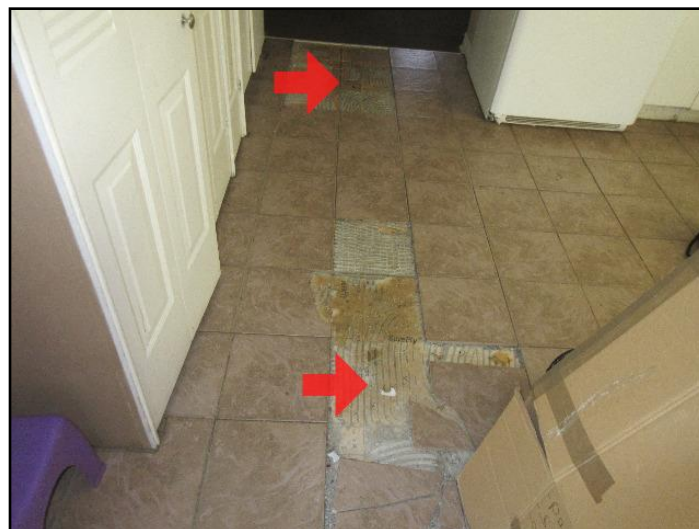
31. Condition: • [Tiles missing](#)

Implication(s): Trip or fall hazard

30. Tiles missing

Task: Repair

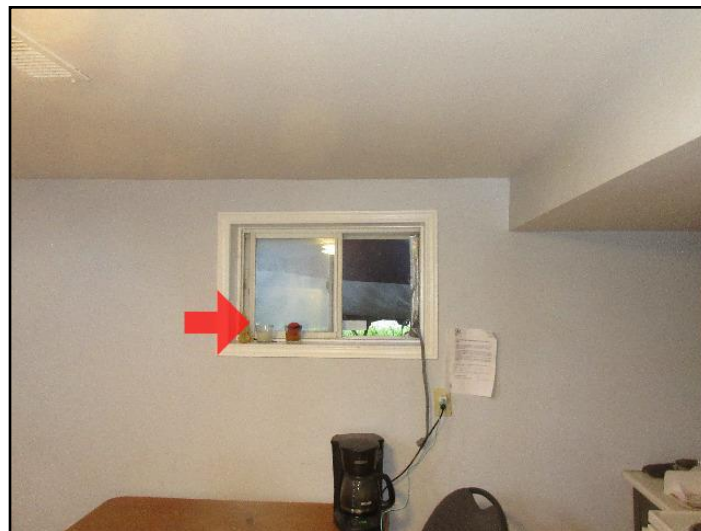
The windows are too small for egress.

33. Condition: • [Too small](#)

31. Too small

Task: Further evaluation

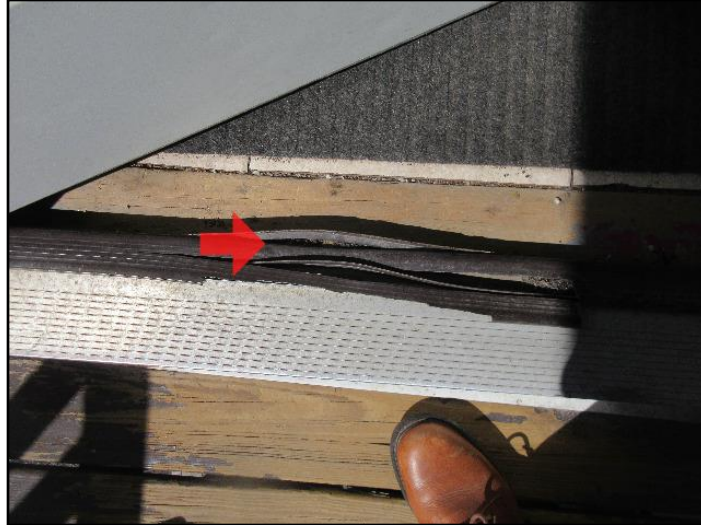
34. Condition: • [Weatherstripping missing or ineffective](#)

32. Weatherstripping missing or ineffective

Task: Repair

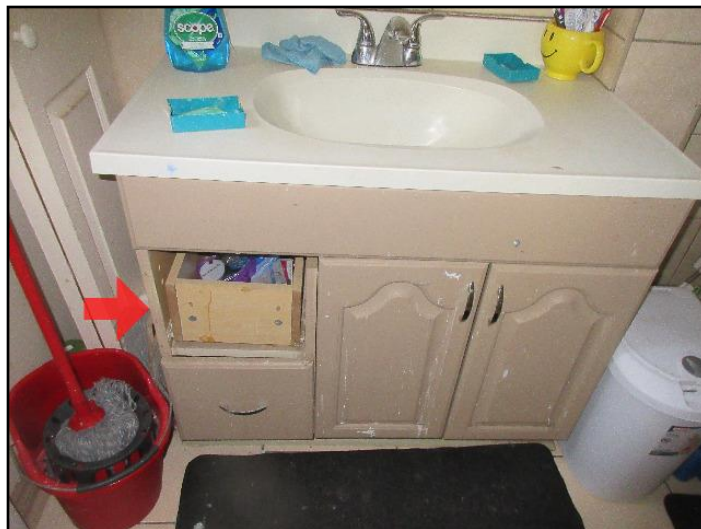
35. Condition: • [Pieces missing or loose](#)

Door missing

Implication(s): Damage or physical injury due to falling materials

33. Pieces missing or loose

Task: Repair

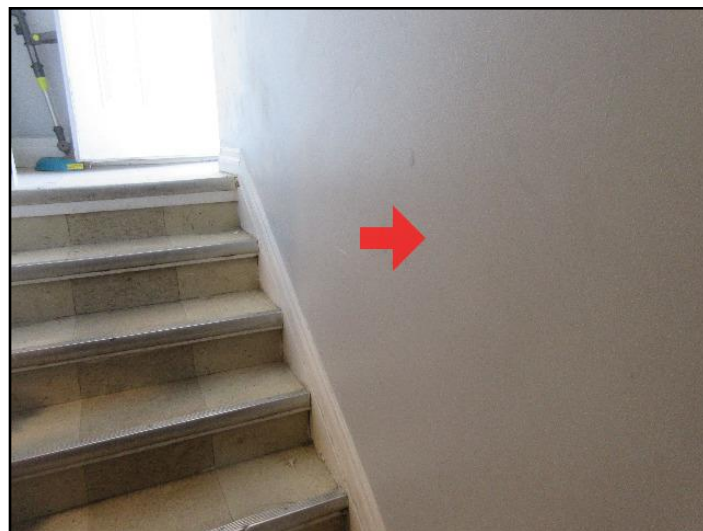
36. Condition: • [Missing](#)

Implication(s): Fall hazard

34. Missing

Recommend to have a railing installed (Safety Issue)
